**DISTRICT OF COLUMBIA
WATER AND SEWER AUTHORITY**

**PROJECT: MUNICIPAL SEPARATE STORM SEWER SYSTEMS (MS4)
PERMIT OUTFALL REPAIR SCHEDULE AND REPORT**

LOCATION: WASHINGTON, DC

DATE: JUNE 2013

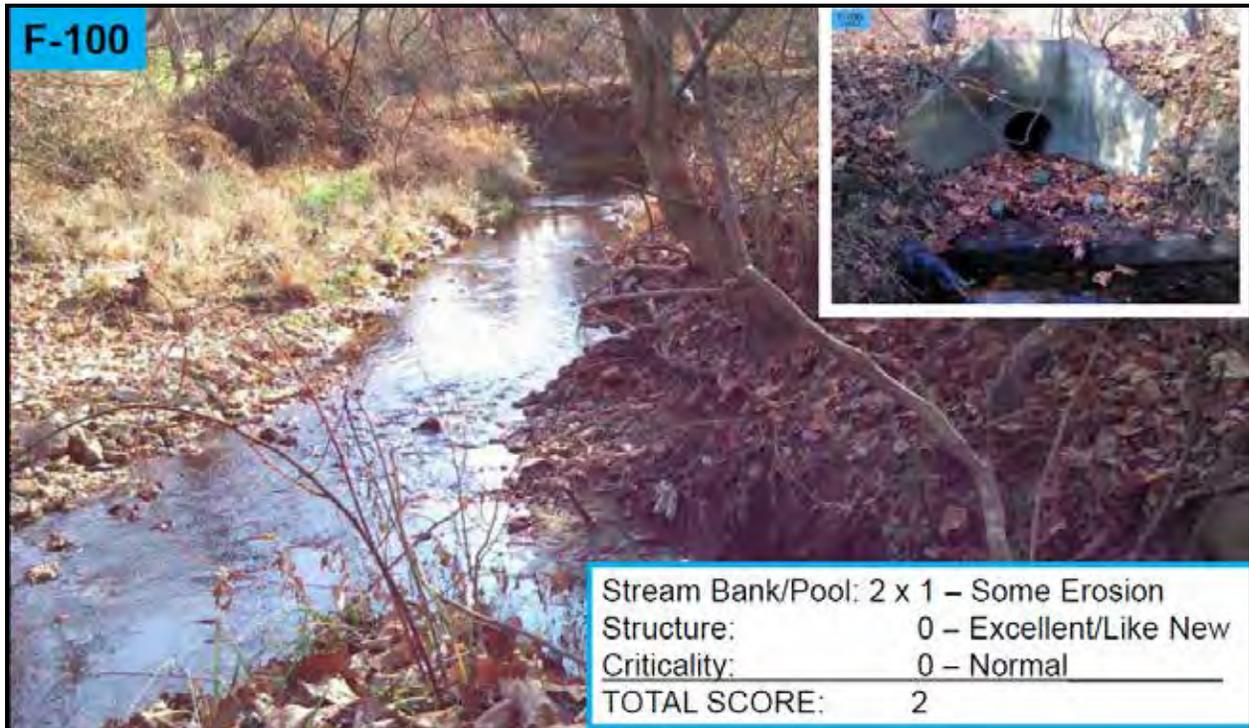
F-100

Figure 3-0(a), Example Outfall with Total Score 0-3

Stream Bank/Pool:	2 x 1 – Some Erosion
Structure:	0 – Excellent/Like New
Criticality:	0 – Normal
TOTAL SCORE:	2

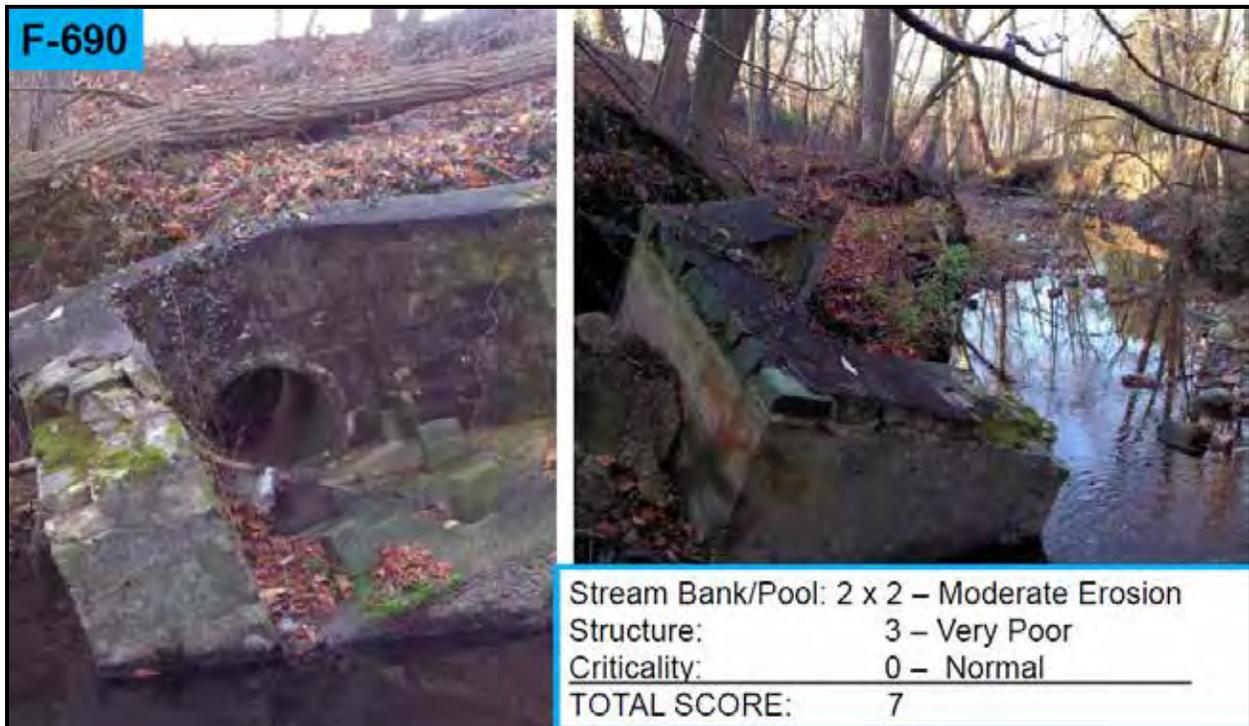
F-690

Figure 3-0(b), Example Outfall with Total Score 4-8

Stream Bank/Pool:	2 x 2 – Moderate Erosion
Structure:	3 – Very Poor
Criticality:	0 – Normal
TOTAL SCORE:	7

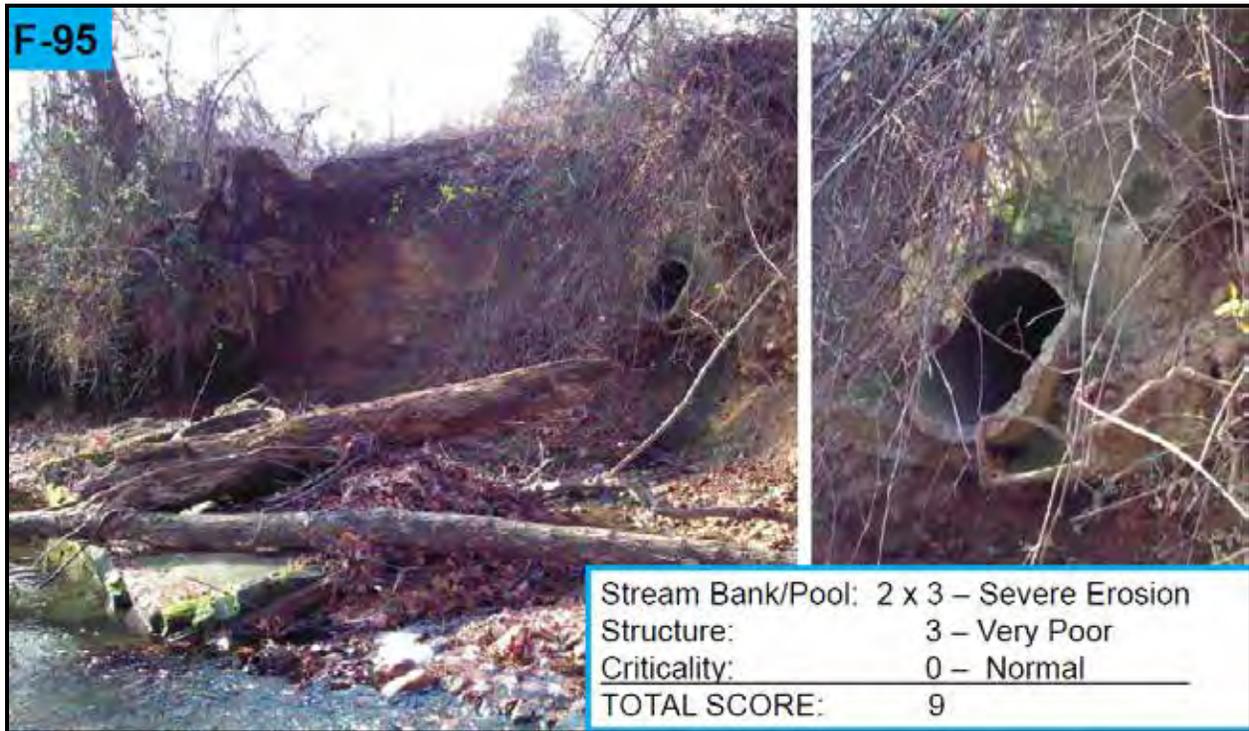
Figure 3-0(c), Example Outfall with Total Score 9-11
