**DISTRICT OF COLUMBIA
WATER AND SEWER AUTHORITY**

**PROJECT: MUNICIPAL SEPARATE STORM SEWER SYSTEMS (MS4)
PERMIT OUTFALL REPAIR SCHEDULE AND REPORT**

LOCATION: WASHINGTON, DC

DATE: JUNE 2013

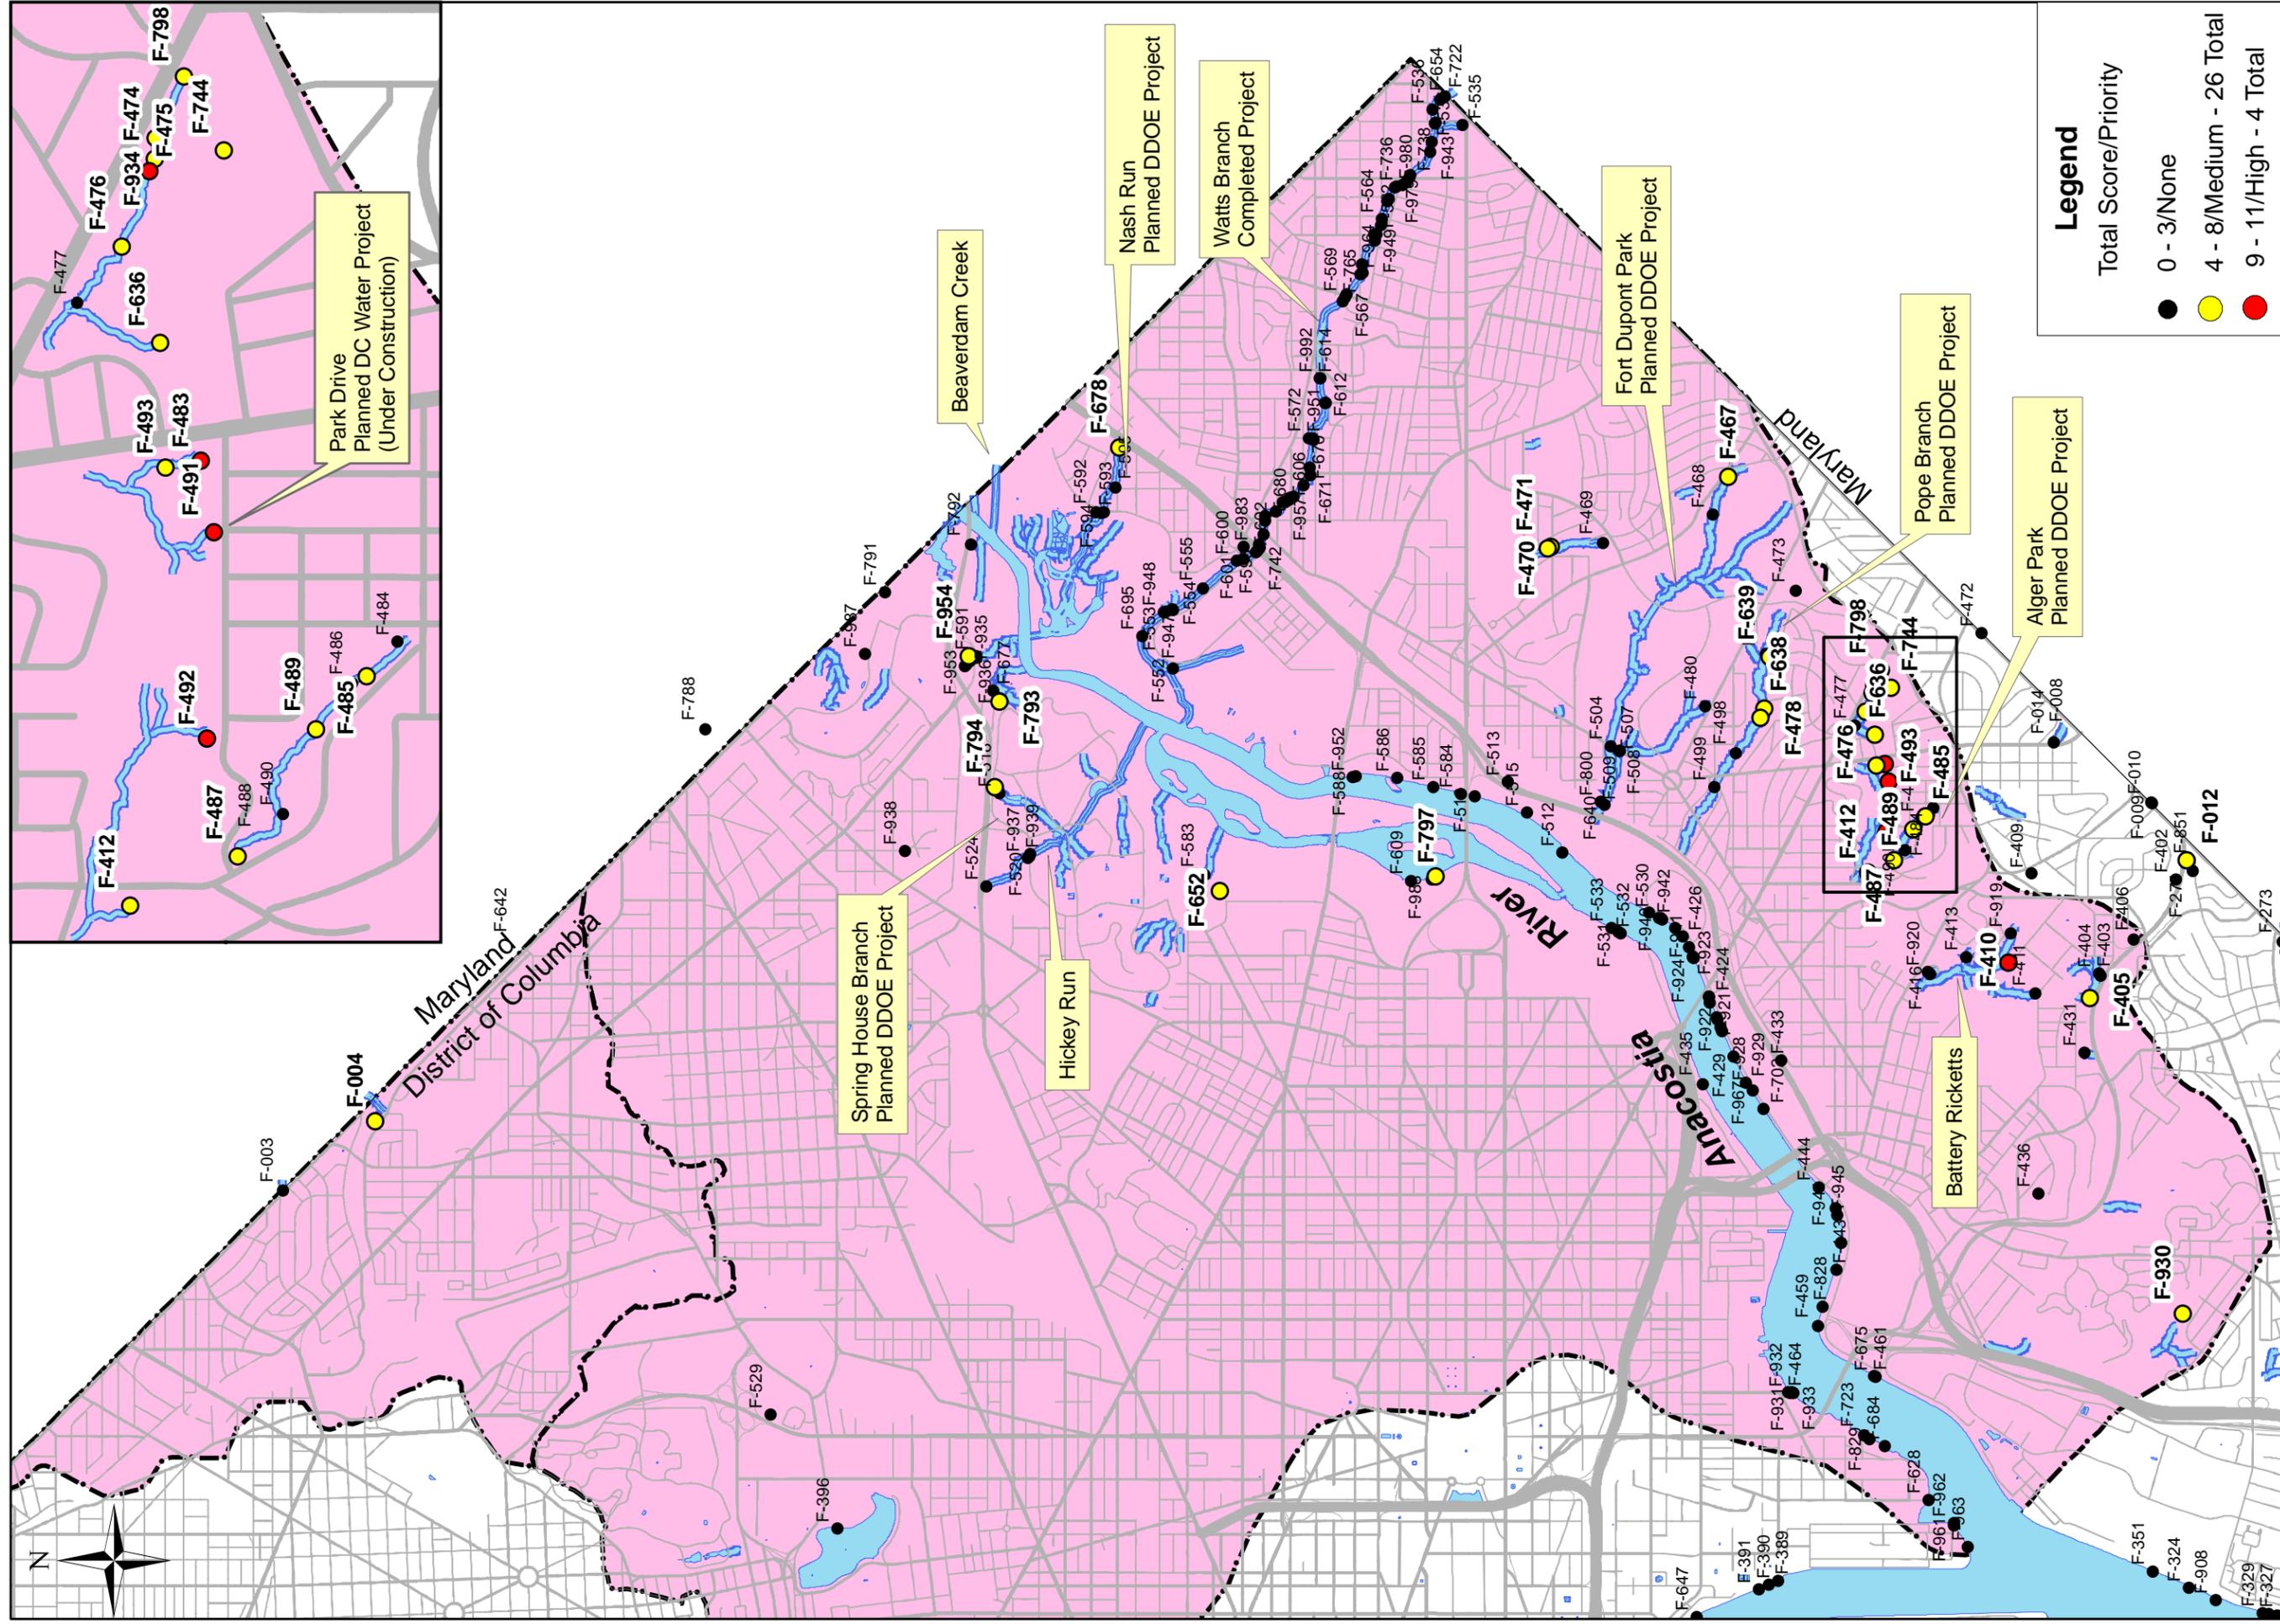
Figure 3-3
Anacostia Watershed
Outfall Condition Assessment
MS4 Outfall Program Report

- 0 - 3/None
- 4 - 8/Medium - 26 Total
- 9 - 11/High - 4 Total
